**SPECIAL ENGINEERING SERVICES TO
ESTABLISH INSPECTION CRITERIA FOR
BEARINGS TO IMPROVE LIFE PREDICTION**

FINAL ENGINEERING REPORT

SwRI Project 15-4012

Warner Robins Air Logistics Command
Directorate of Materiel Management
Robins Air Force Base, Georgia 31093

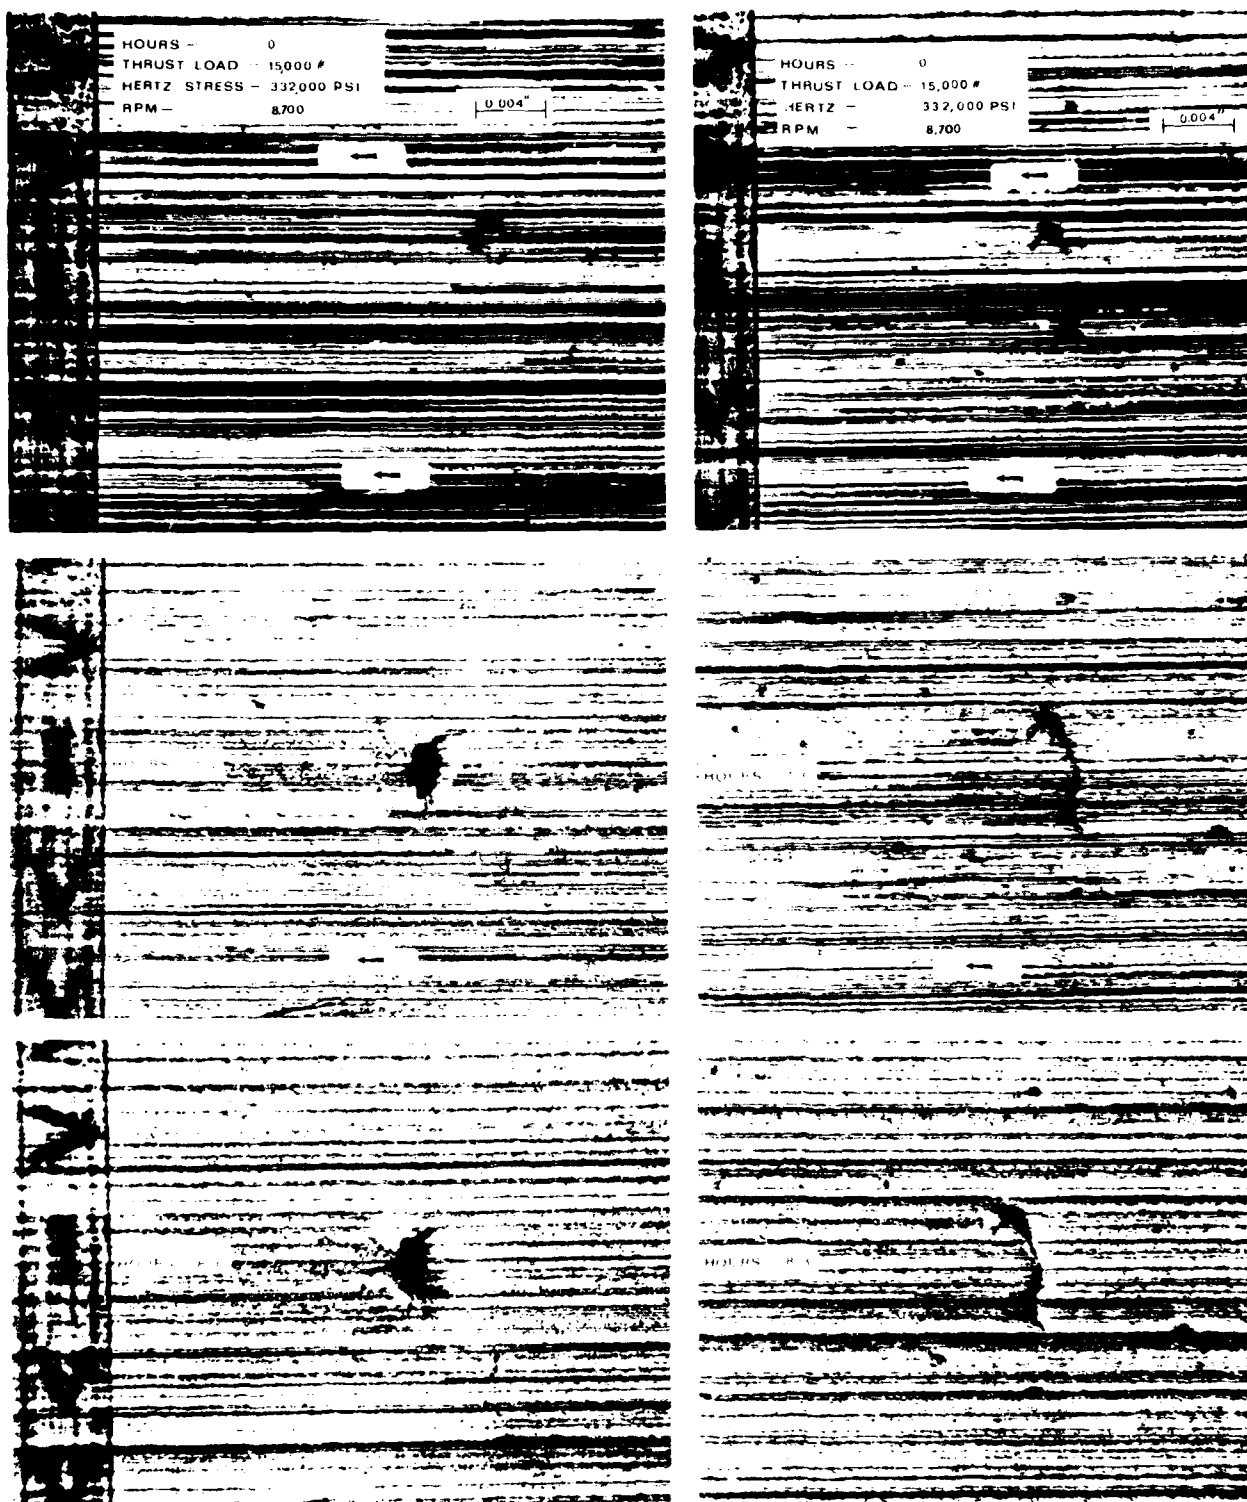
FIGURE F8. SURFACE PHOTOMICROGRAPHS OF TWO FLAW LOCATIONS ON J57-#4 BEARING S/N 748A-1 INNER RACE (nonloaded half in service) "BEFORE" AND "AFTER" 7.3 and 8.3 HRS ENDURANCE TESTING (S10981).

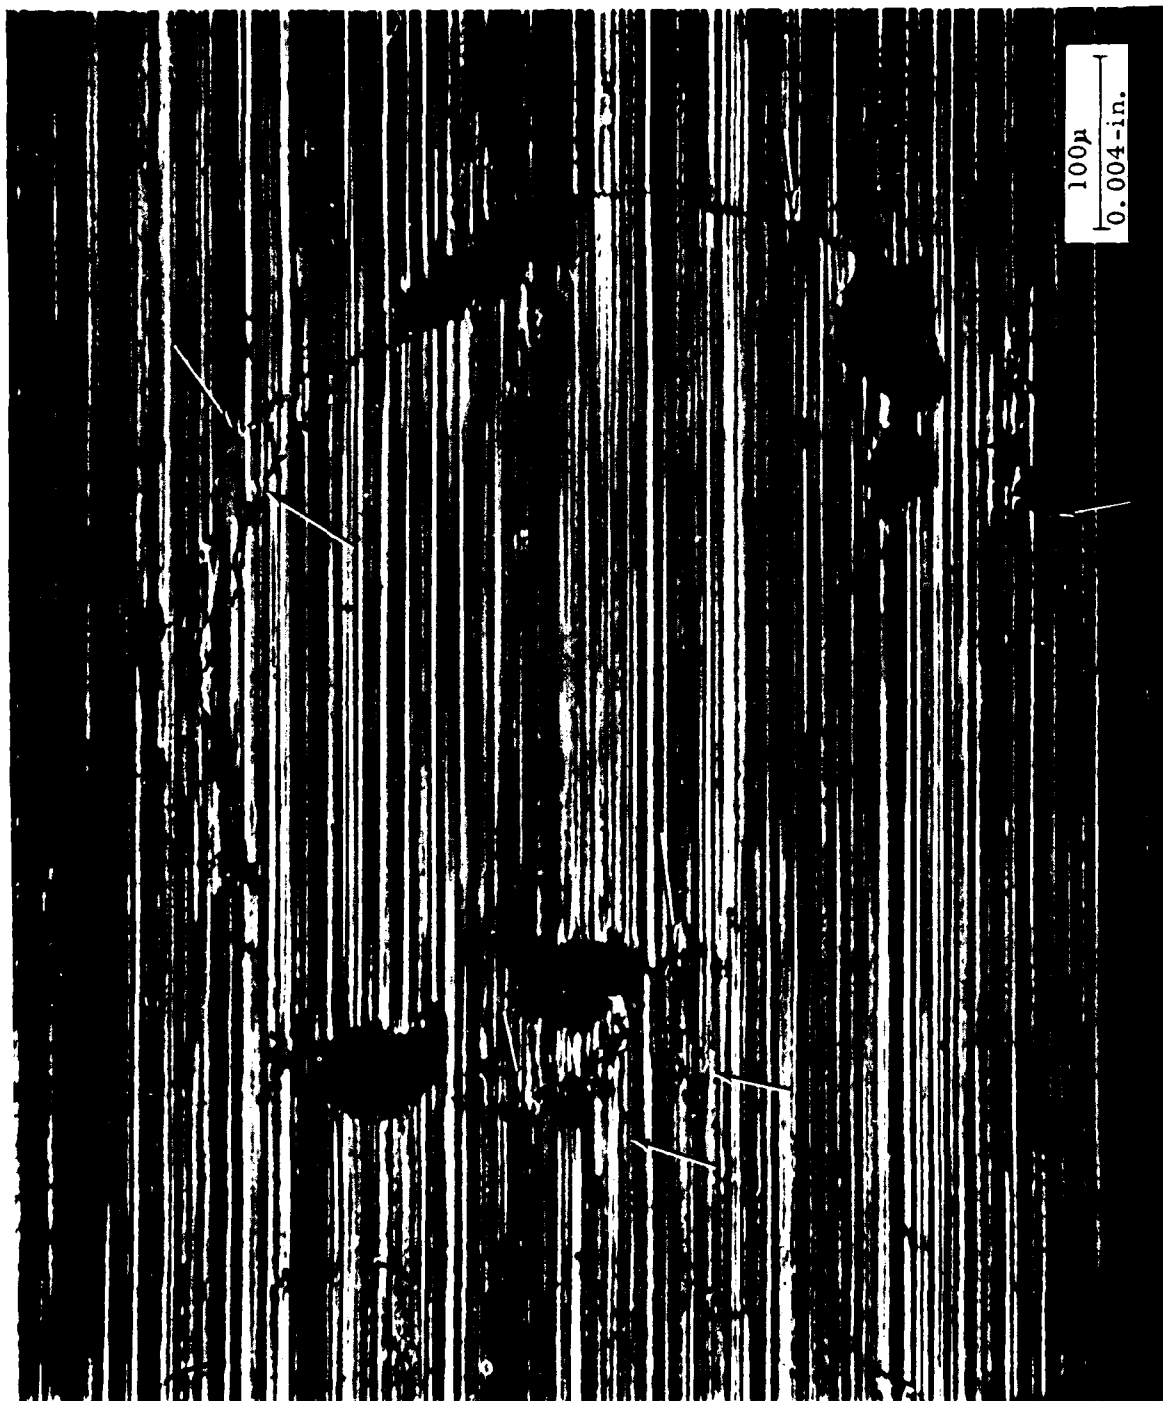
FIGURE F24. SURFACE PHOTOMICROGRAPH OF CRACKS IN VENDOR REMORKED BEARING (Signature Location 0013-1288 on J57-#4 Bearing S/N 6850-1 Inner Race, loaded Half S11281(3), 1668 hrs. service).

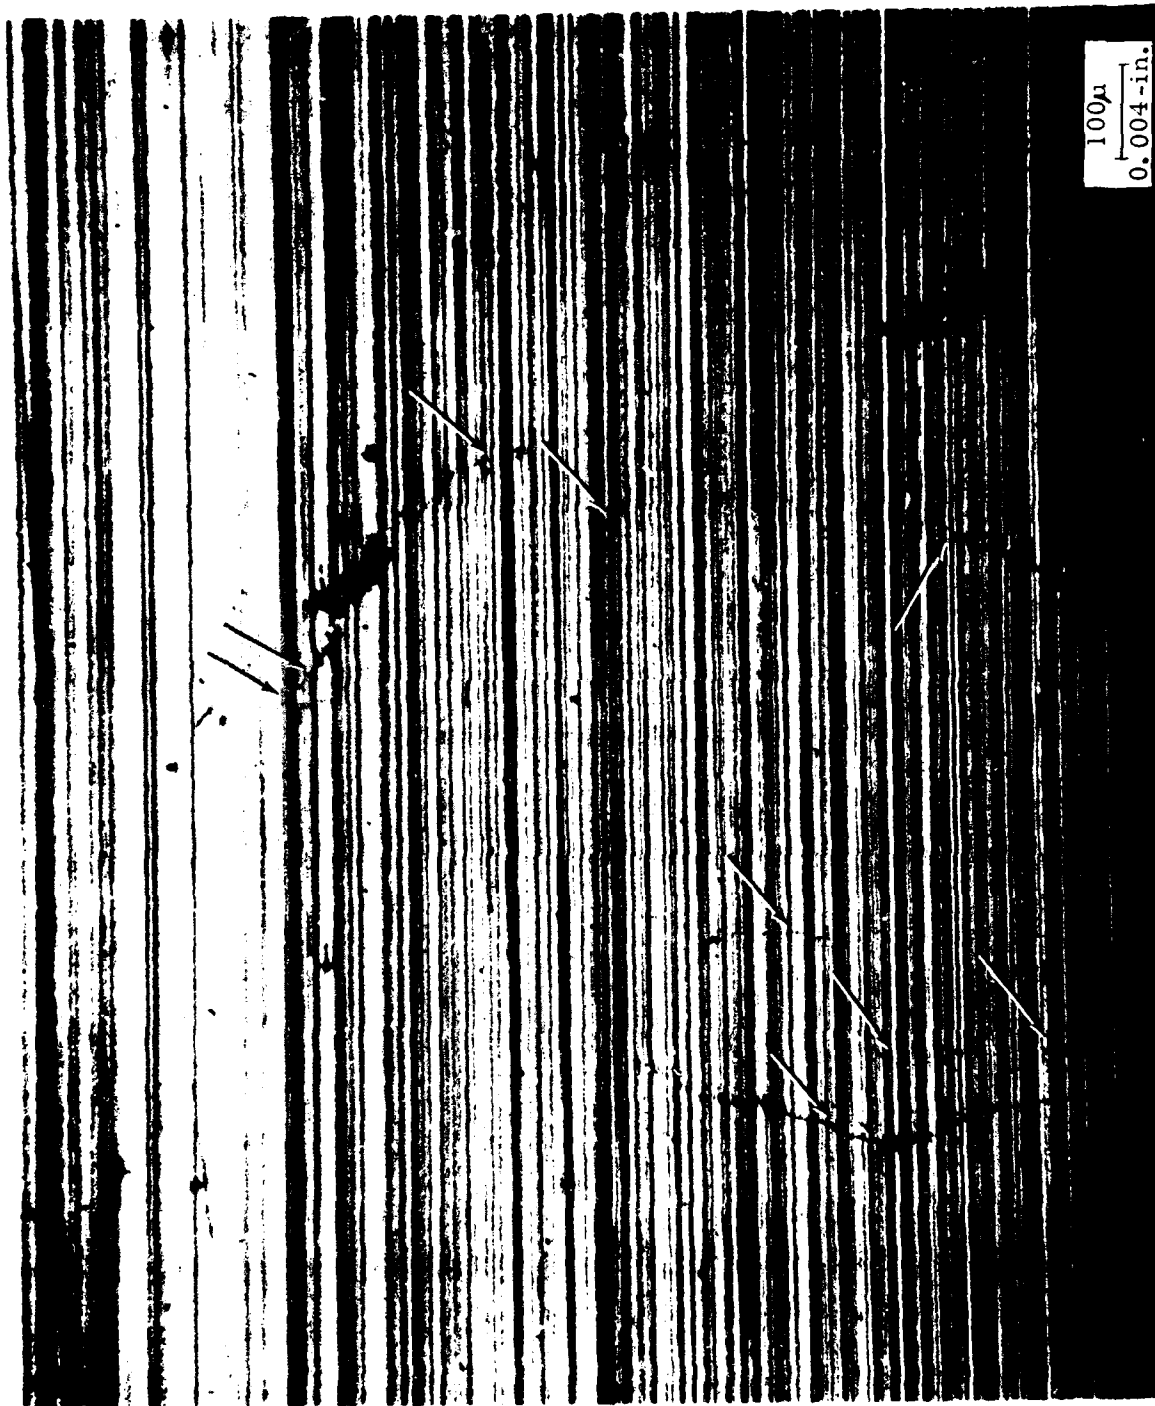
FIGURE F26. SURFACE PHOTOMICROGRAPH OF CRACKS IN VENDOR REWORKED BEARING (Signature Location 0007, 0008-2127 on J57-#2 Bearing S/N Z916-2 Outer Race S00722 (5), 7259 hrs. service).

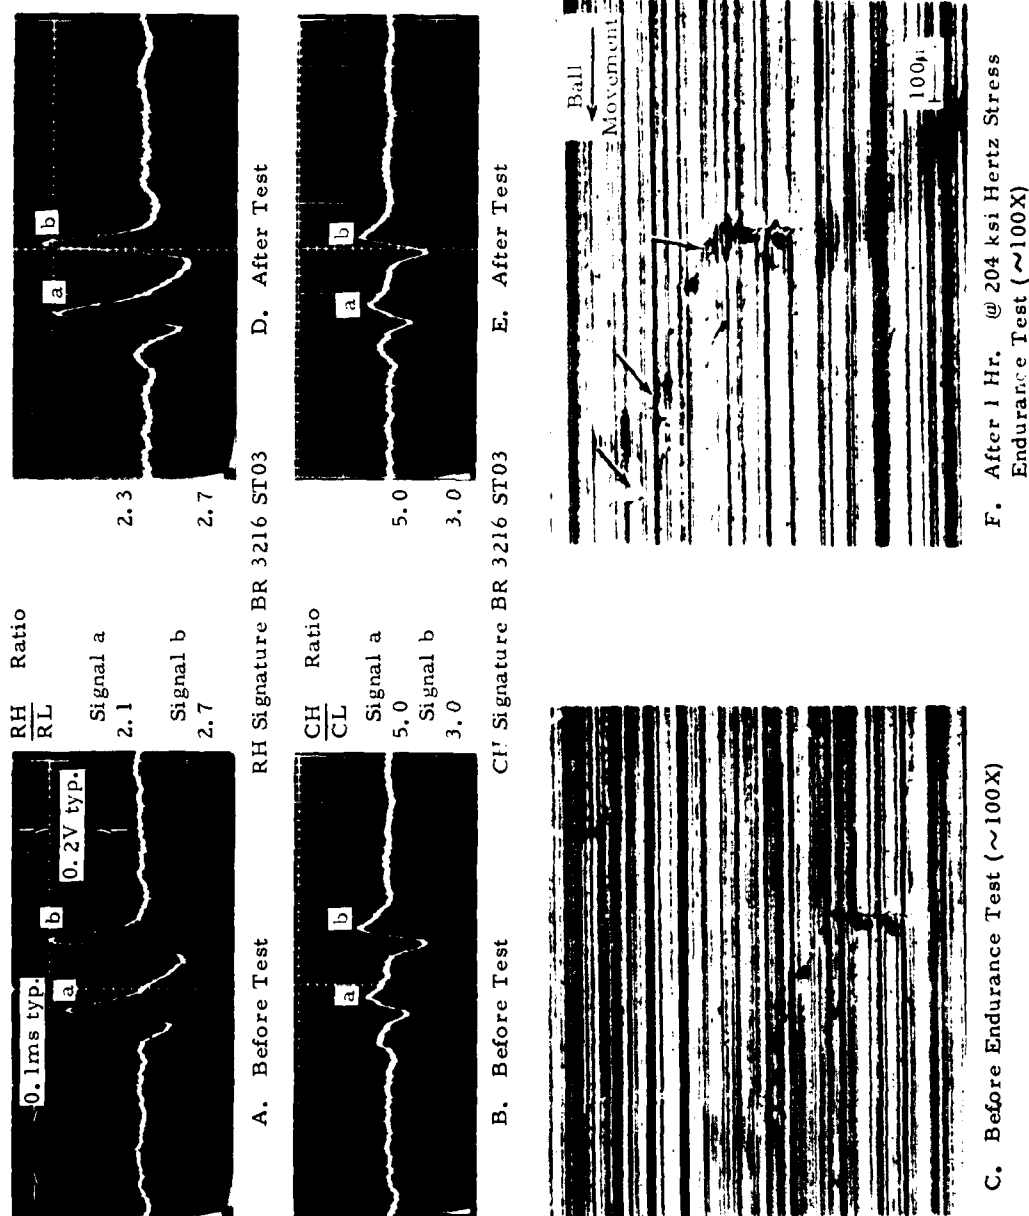
FIGURE F27. MAGNETIC PERTURBATION SIGNATURES FROM AND SURFACE PHOTOMICROGRAPHS OF CRACK NETWORK "BEFORE" AND "AFTER" 1 HR ENDURANCE TEST [S00591(3)].

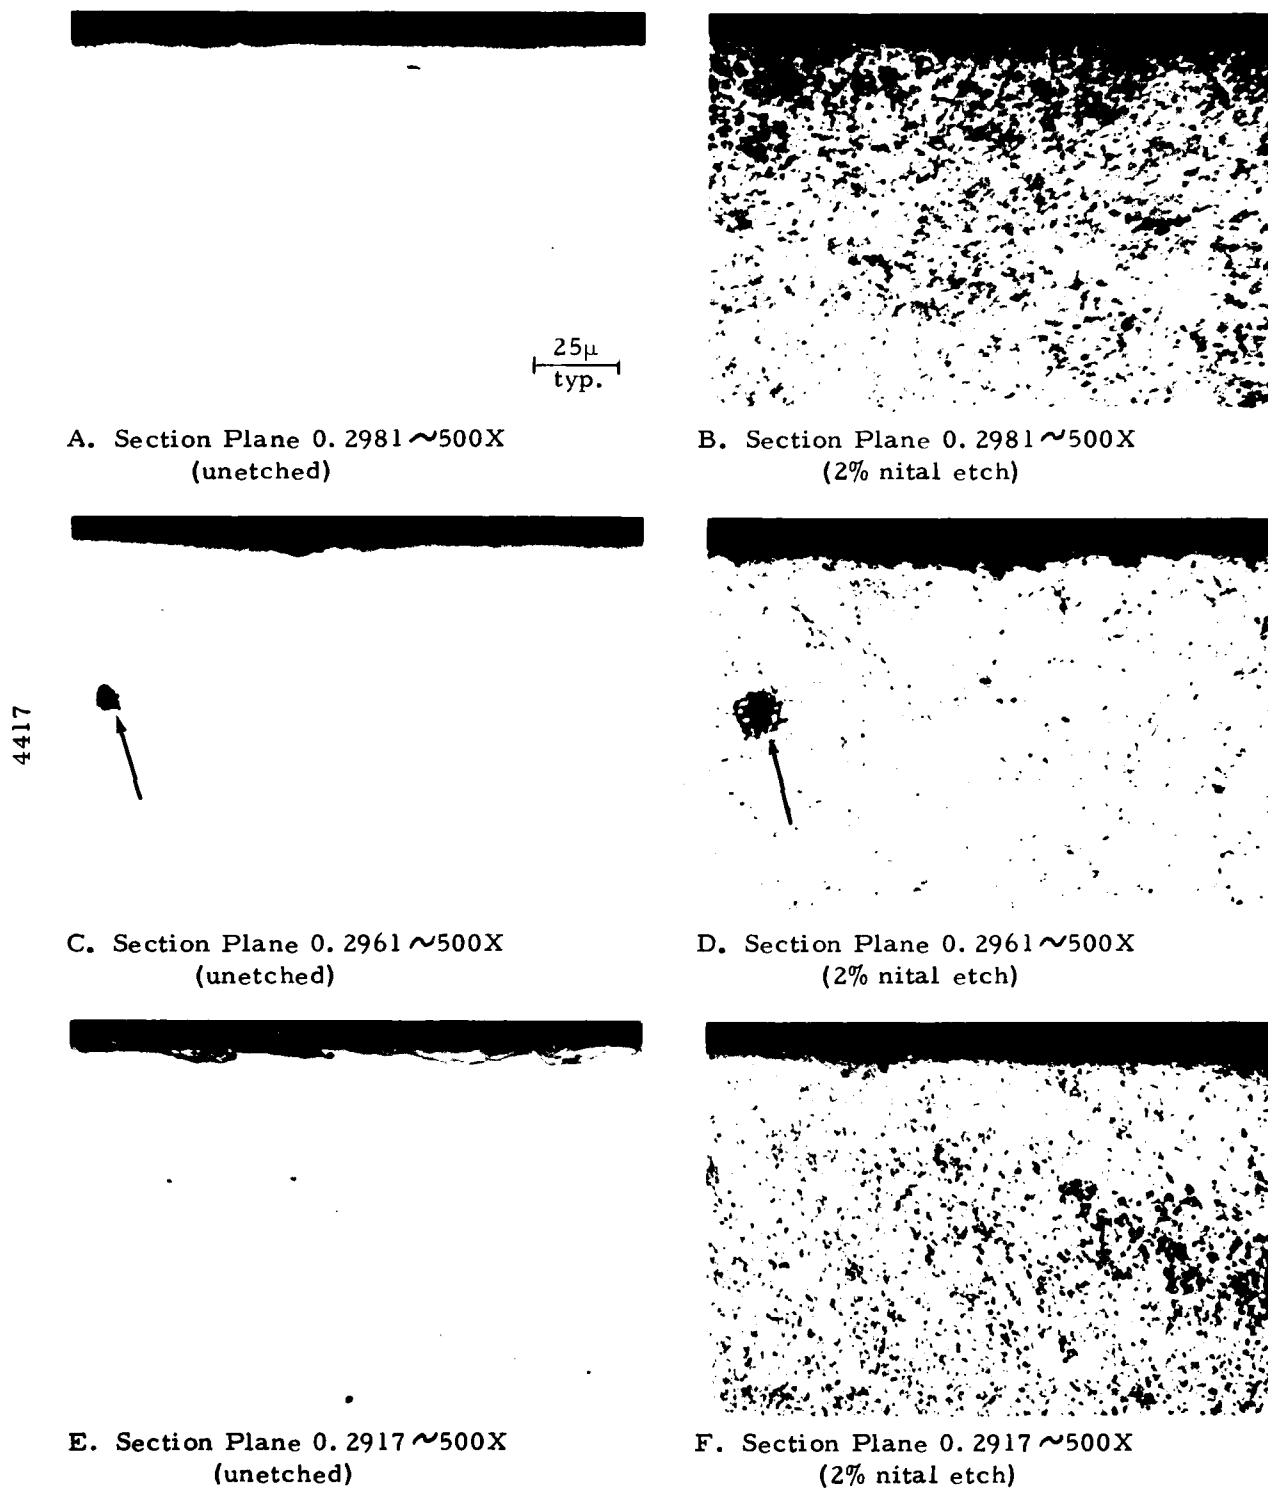
FIGURE F33. REPLICATION AND SECTIONING RESULTS FOR SURFACE IMPERFECTION AT 0003-1684, J57-#4 BEARING (S/N 141C-1) INNER RACE S10071(2) (reparable reject, 7946 hrs.).
